Oil immersion heater replacement for Advance model 6150 only.
Once reservoir is free of the enclosure, spin out defective heater, clean the threads, wrap new heater threads with Teflon tape and tighten firmly.
Questions, call 800-843-3625

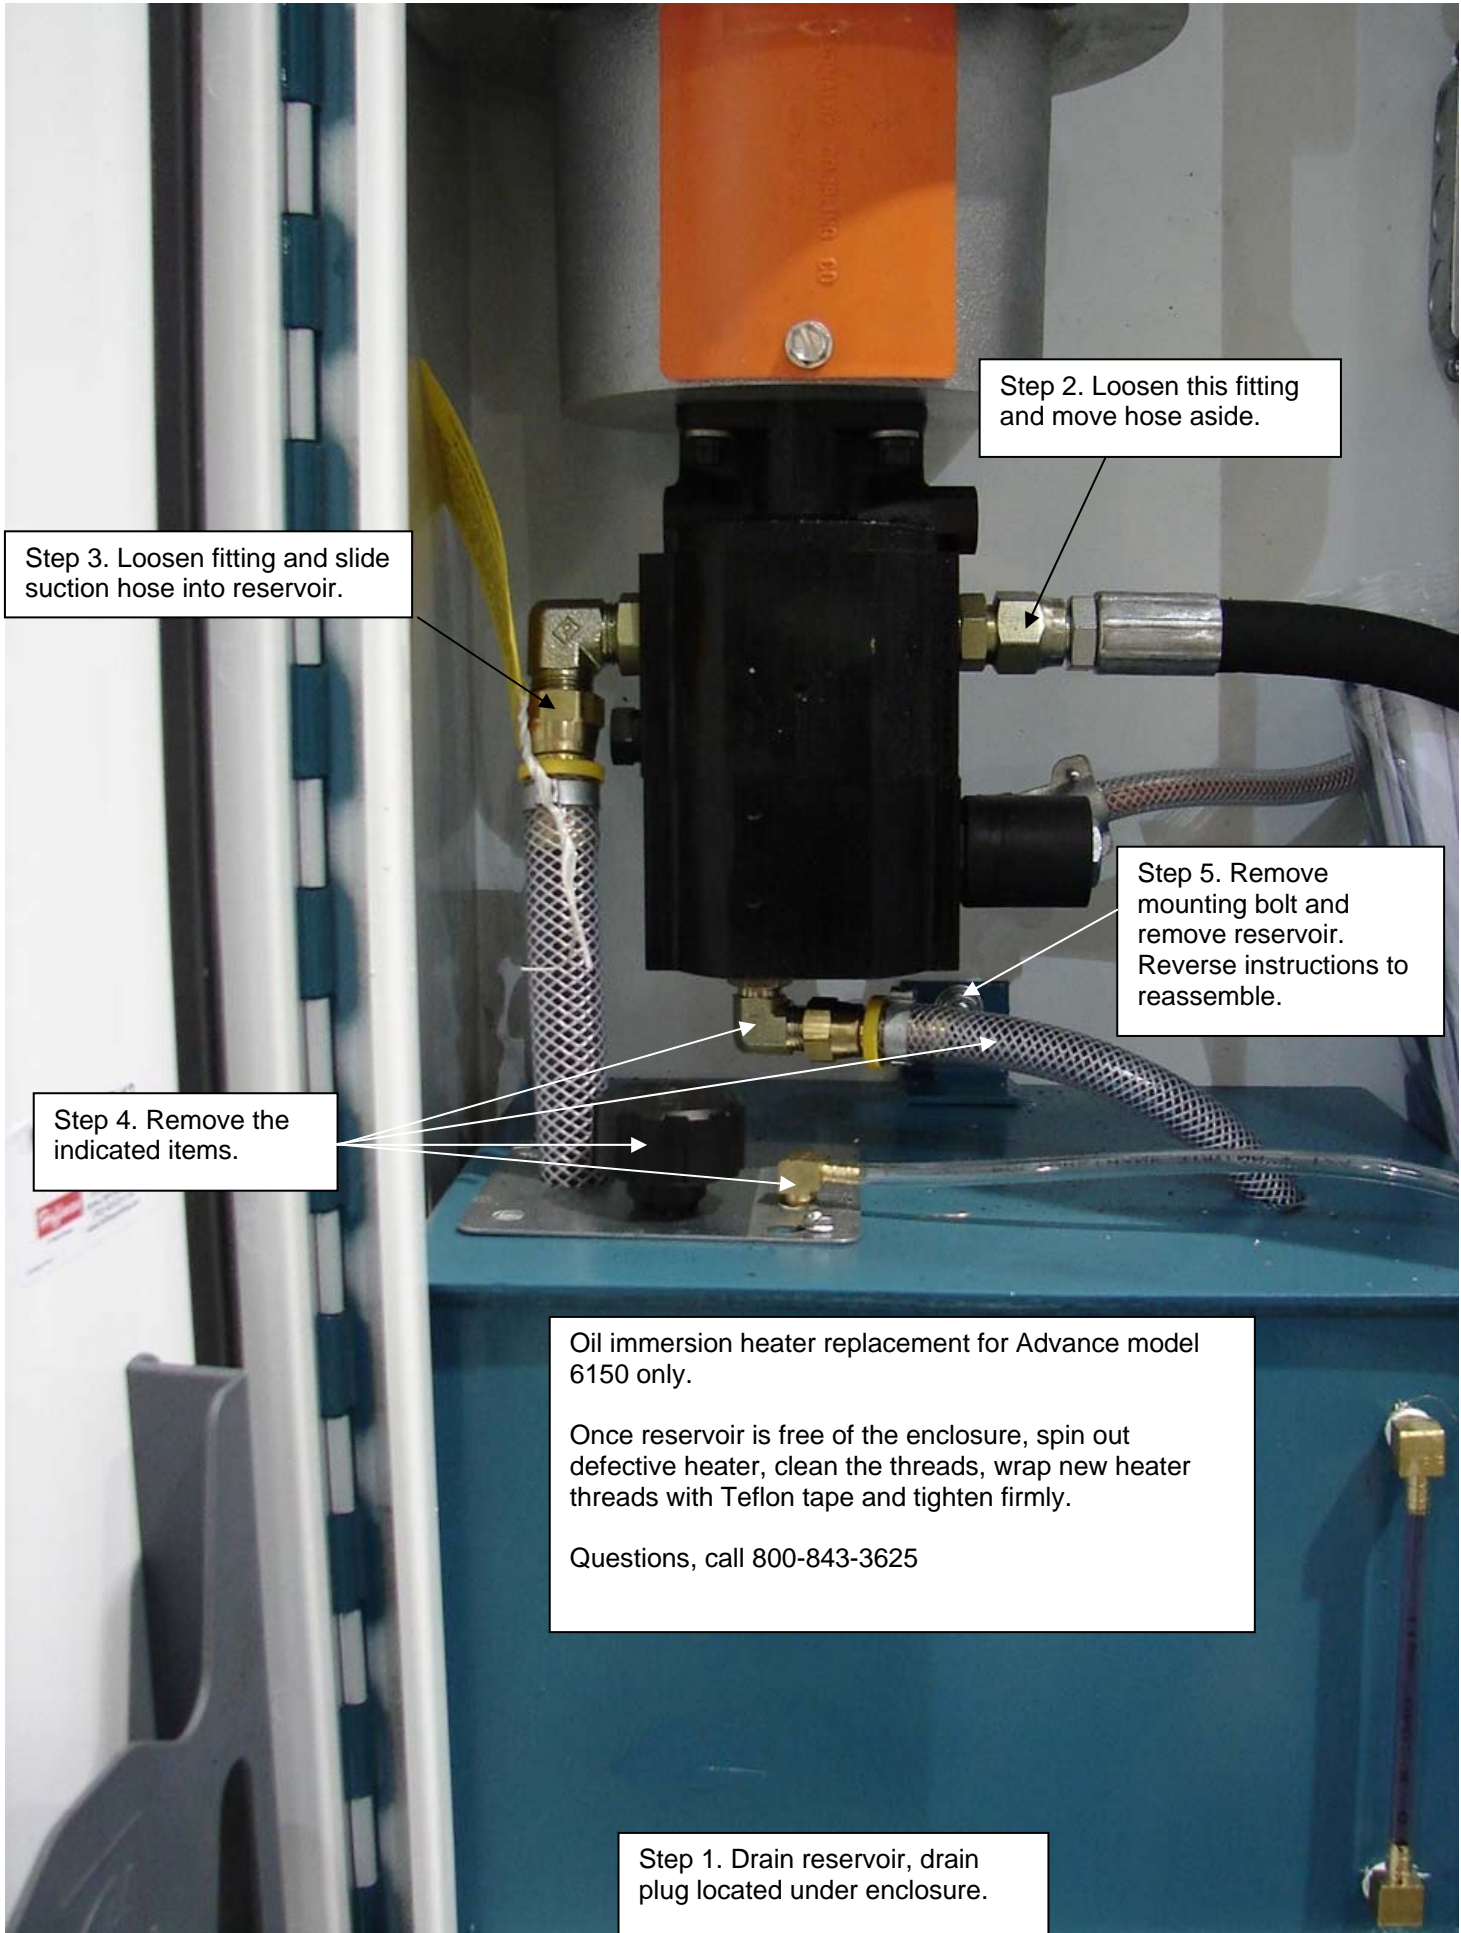
Step 2. Loosen this fitting and move hose aside.

Step 3. Loosen fitting and slide suction hose into reservoir.

Step 5. Remove mounting bolt and remove reservoir. Reverse instructions to reassemble.

Step 4. Remove the indicated items.

Step 1. Drain reservoir, drain plug located under enclosure.
